HISTORY OF A LANDFILL SITE NEAR LAS CRUCES, NM

April Lewis, Environmental Research Institute of Michigan

Ed Van Eeckhout, Los Alamos National Laboratory

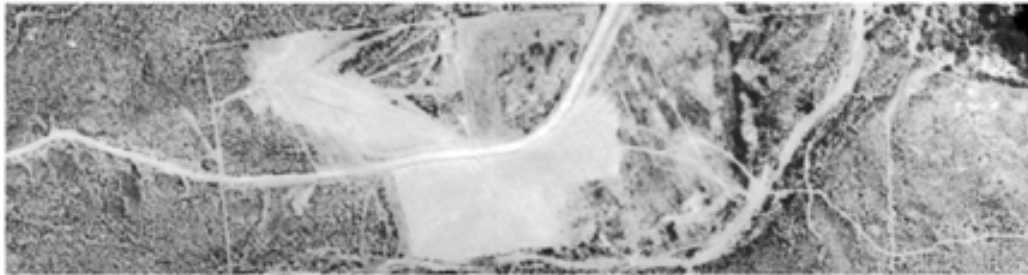
Identifying and tracking the transformed features of the landfill not only provided estimates of annual growth, but also provided clues to significant changes concerning topography. Some transformations are significant enough to change the behavior of the watershed. These modified areas are shown in Figs. 4 (a) through 4 (c).

Fig. 4 (a) Gross morphology, 1994.

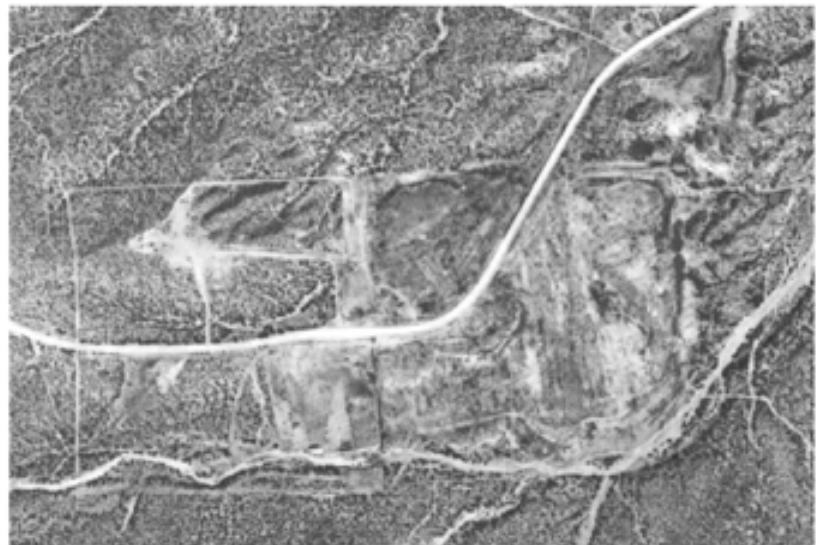
Fig. 4 (b) Fence line, 1989.

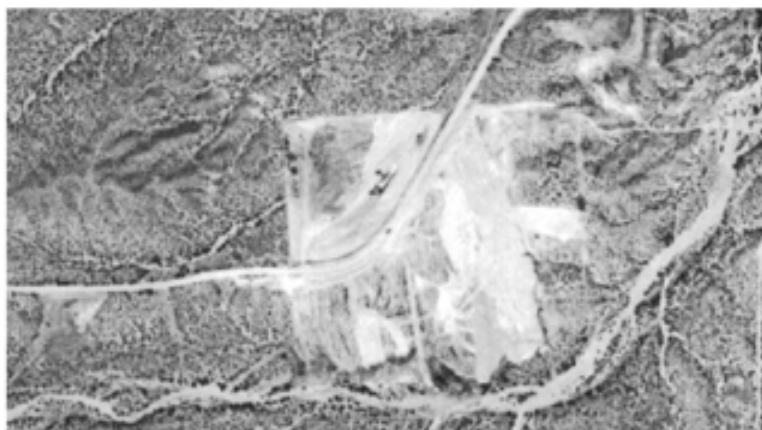
Fig. 4 (c) Fan shape, square boundaries, 1980.

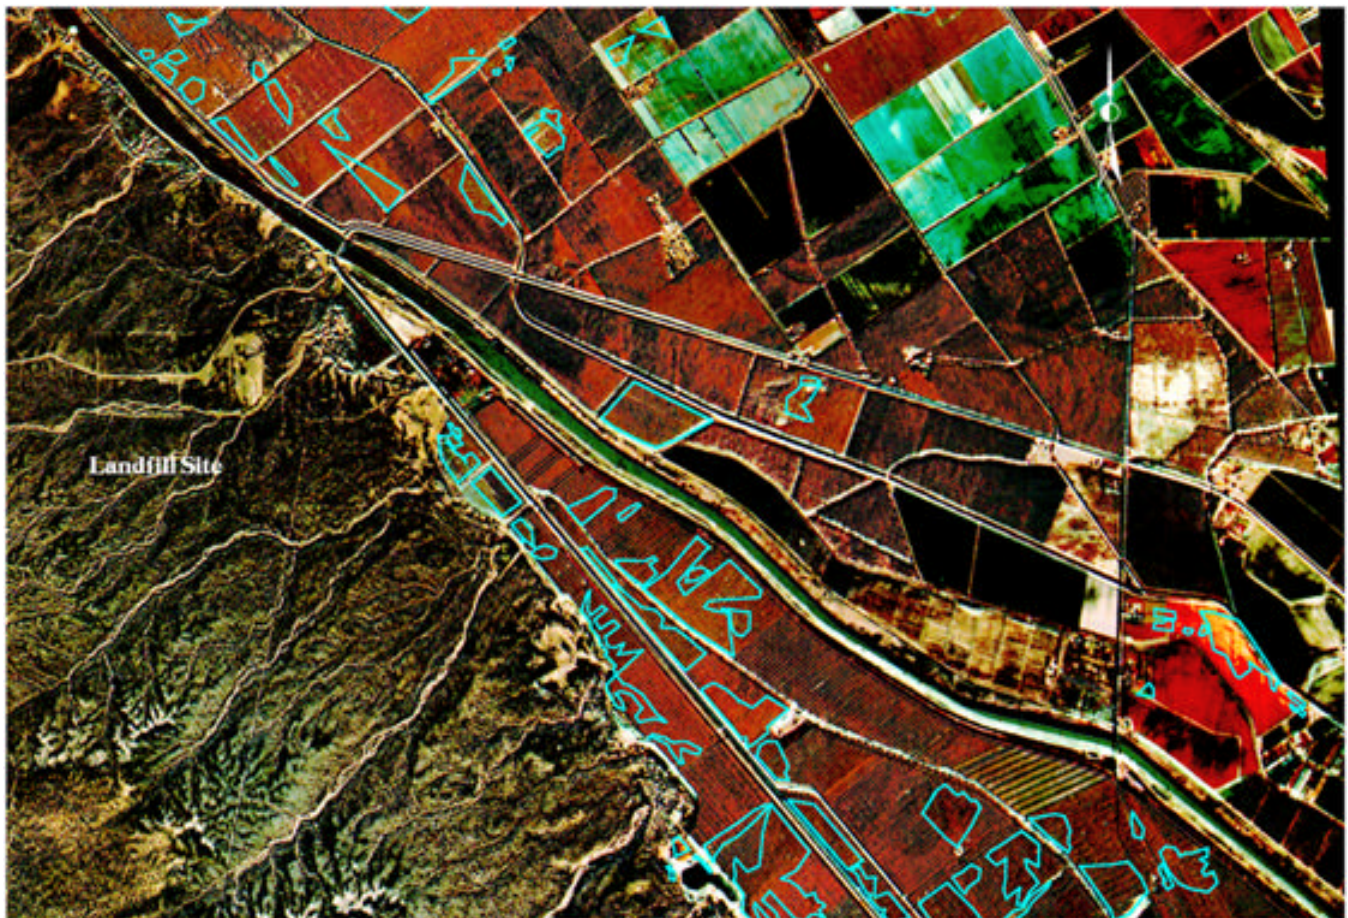
Fig. 6. Image difference between 1984 and 1986. Color IR images of the Las Cruces landfill. The cyan vector delineates areas of vegetation stress. Image scale is 1:58,000 ft.

The change image was examined to detect areas of vegetation which showed initial stress (dark magenta or pink), areas of advanced stress (white or pink-purple), and areas of dead or defoliated vegetation (yellow, blue, and green). All three levels of decay were delineated into one vector. Figure 6 depicts the cyan vector overlaid on the CIR image which encompasses areas of vegetation stress. Now that there was some evidence of vegetation stress and it was mapped out, it could be merged with

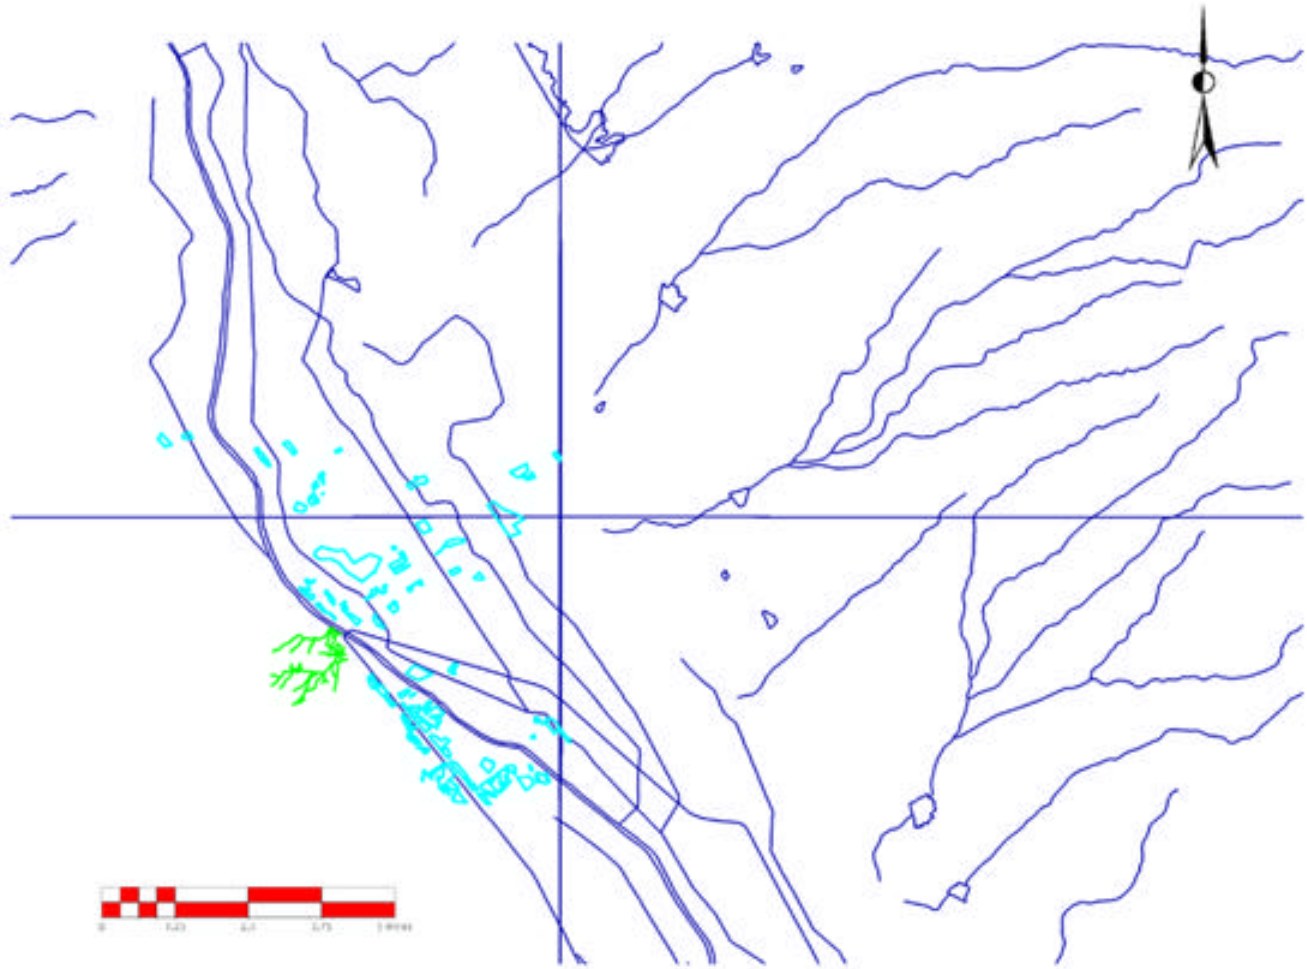
hydrography vectors of the area. The merged vectors would reveal trends in vegetation stress and local water flow in and around the landfill site. Figure 7 shows hydrology and vegetation stress vectors merged. The vectors show that south and east from the landfill there are several areas of stressed vegetation. The stressed vegetation shows a migration tendency southward along the west side of the Santo Tomas Drain. This migration coincides with the shallow ground-water discharge patterns, which discharge to drains and ultimately flows into the Rio Grande.

Fig. 7. Hydrography vector in dark blue merged with vegetation stress vector in cyan. Landfill drainage is in green.

A good preliminary characterization and analysis has been completed with the outcome being the Las Cruces Municipal Landfill is potentially a threat to the local water table. Monitoring wells for leachate and drinking water should be established. A total of 6 would be adequate, one of each kind located on the southeast, south, and northwest faces. Several wells south along the Santo Tomas Drain would also be beneficial. Soil samples should be taken over a uniform area surrounding, and including the site. Future characterization work would include sub-surface characterization using variograms or Kriging models for subsurface contamination (plume detection/migration). A 3-D model should be created for combining the surface and sub-surface data.
